## TECHNICAL NOTE / CASE STUDY

### Bubbles Because Of Bad Vacuuming — EVA Laminated Glass Safety Glazing Case Study and Solutions

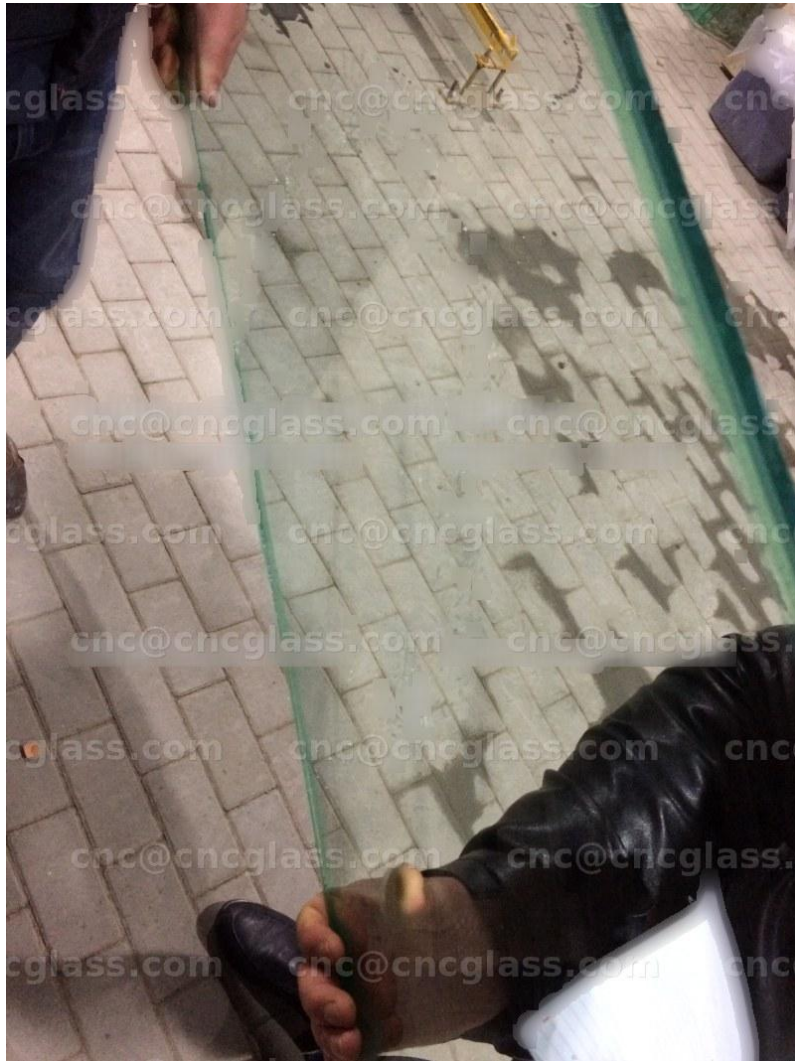
Figure 1. Failed tempered EVA laminated glass — scattered bubbles across the pane (Glazier E).

**First analysis:** the vacuuming system was **not strong enough**. From the photos, the bubble areas were **large and gathered in one place, close to the edges**, because vacuuming was not strong enough to pull the air out. Peter asked Glazier E to check the vacuum value and whether the vacuum pump was working well.

Soon afterward, Glazier E reported that the vacuum pump **filter was completely choked**. After cleaning it and loading glass again to control the process, **the problem was well solved**.

For similar tempered EVA lines using 0.76 + 0.38 mm film and multi-stack bags (for example two 6 + 0.76 + 6 couples per floor), treat a vacuum gauge stuck at minimum as a hard stop: open and clean or renew the pump filter and confirm rotation before blaming heat time at 60 °C / 133 °C. Re-qualify with a short trial load after service. Large edge-gathered bubbles after a full cycle are a classic weak-vacuum signature; uneven heat or pipe proximity can contribute, but fix them after the pump path is proven clear.

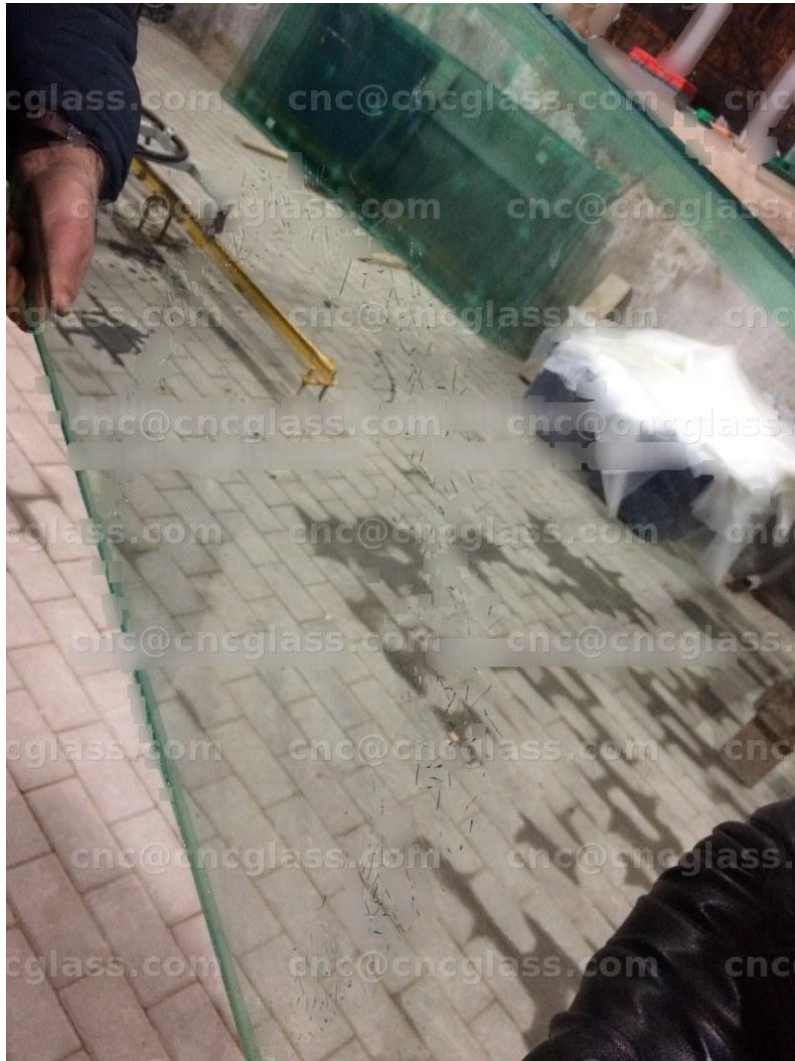
Figure 2. Close-up of gathered / elongated bubbles near the laminated glass edge.

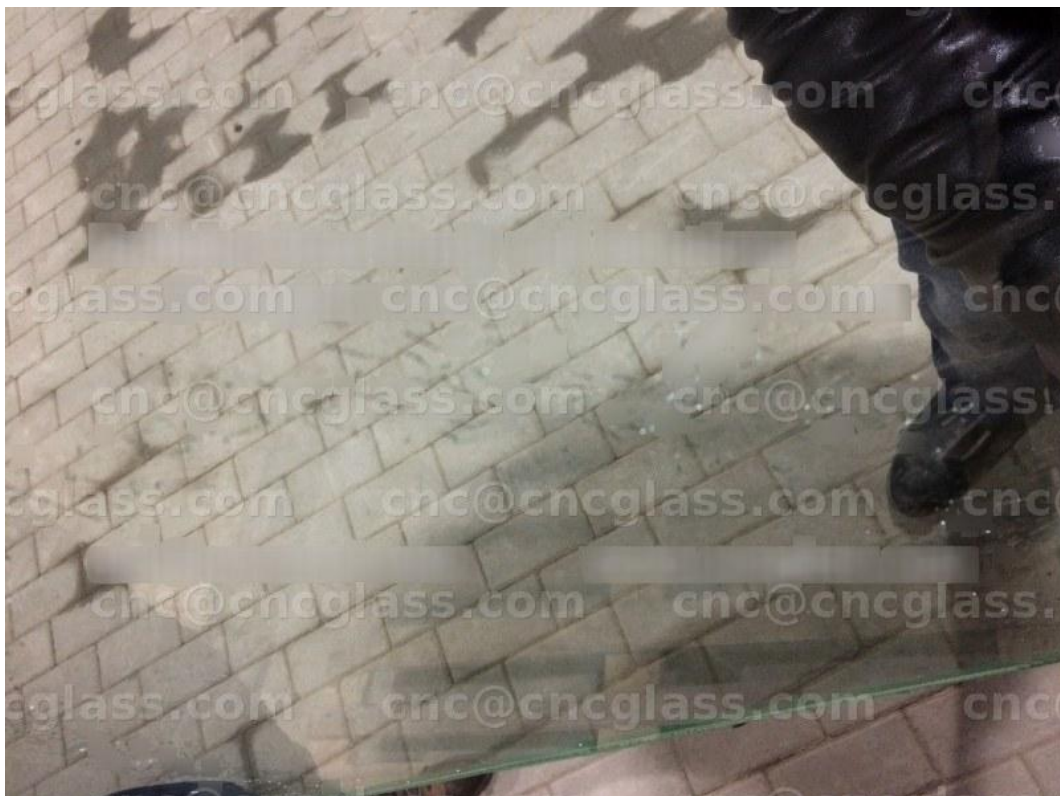
Figure 3. Another failed laminate from the same cycles — wrinkles and bubbles near edges.

**Defect pattern:** mostly wrinkles, close to the edges—consistent with the vacuum diagnosis.
