## TECHNICAL NOTE / CASE STUDY

### Too High Temperature Causing Bubbles in EVA Interlayer Film Safety Laminated Glass — Practical Case Study

By Peter Lin

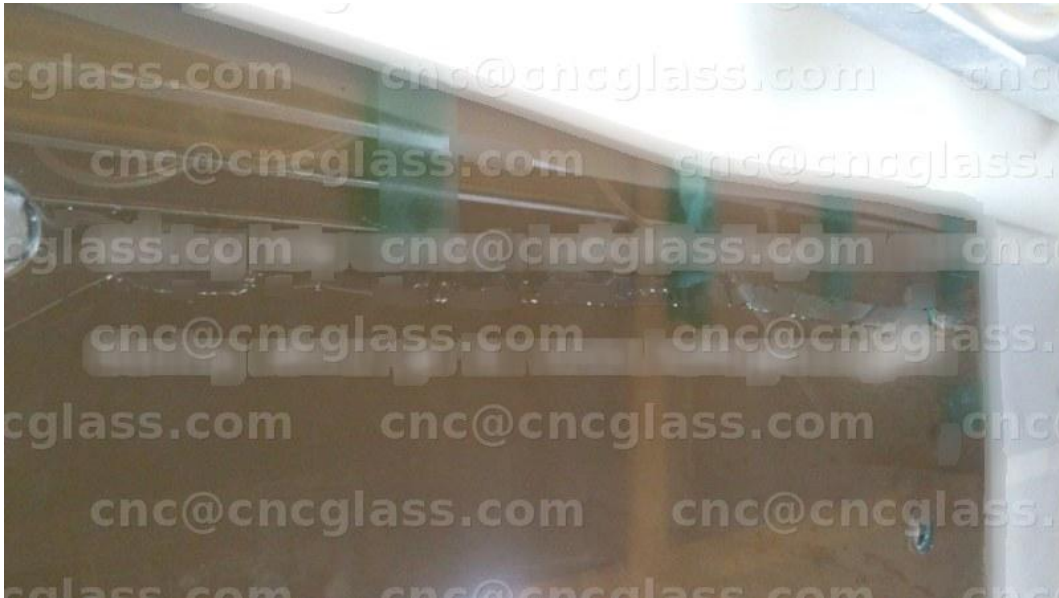
**Result:** big bubbles in the body of the laminated glass.

Figure 1. Failed EVA laminated tempered glass after the initial high-temperature cycle (body bubbles; overlay contact spam softened before watermark).

After reviewing the background, Peter concluded that **140 °C was too high** for this oven and film. Excessively high temperature can break down the compound and cause bubbles in the laminate body.

**Recommendation:** reduce the high-stage temperature from **140 °C to 130 °C**.

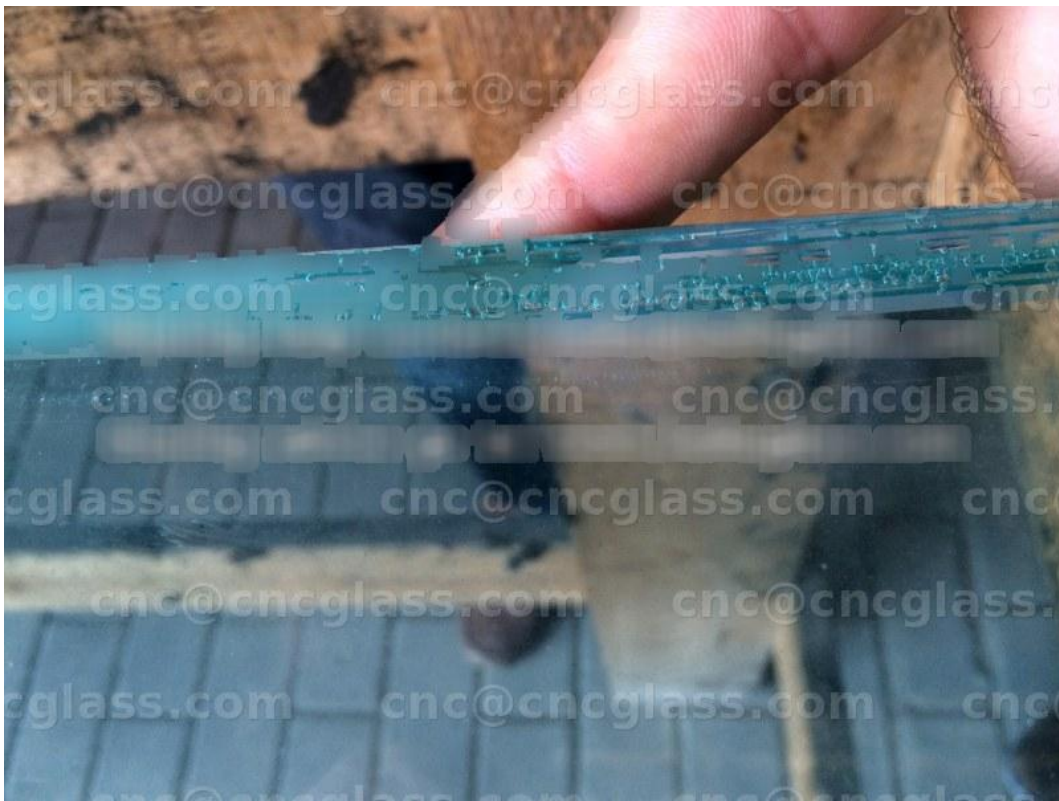
Figure 2. Edge view after the 130 °C trial — micro-bubbles concentrated near the edge (about 3–4 mm inward from the glass edge).

**Remaining issue:** very small bubbles near the edge — not deep inside the pane — about **3–4 mm** inward from the very edge of the laminated glass (also visible on overflowed EVA outside the glass).

Because body bubbles had already been tied to **too high temperature**, and edges of a pre-laminate typically absorb **higher temperature than the center**, Peter recommended reducing the second-stage temperature further from **130 °C to 125 °C**.

Edge-only micro-bubbles a few millimeters inward after the body clears often mean the perimeter still runs hotter than the field. Stepping the high hold down in small increments—while keeping vacuum active through cool-down—is a practical way to find the oven’s workable window for a given film and load.

**Final working high-stage temperature (this oven / this film): 122 °C.**
