### TECHNICAL NOTE

## Bubble Solutions for Laminated Glass with EVA Interlayer Film

By Peter Lin

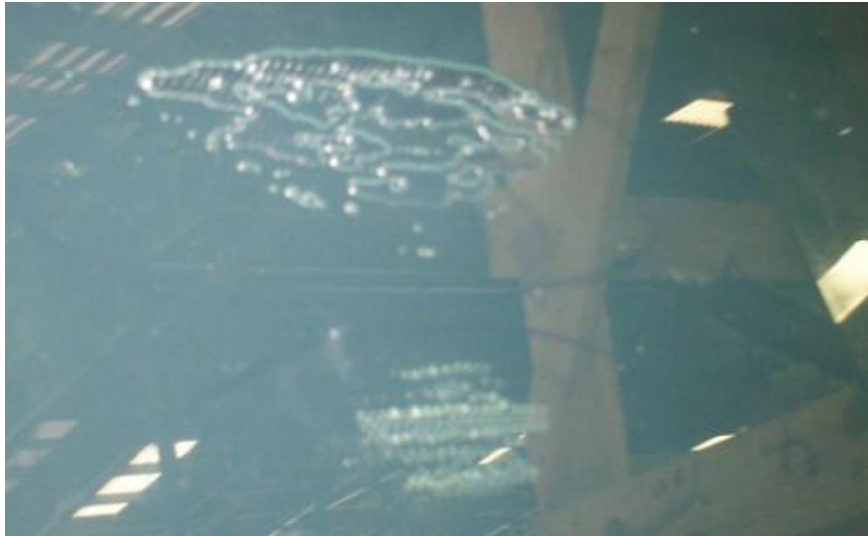
Example: bubble defect in EVA laminated glass (illustrative process photo).

We observed a case in which bubbles appeared in laminated glass even after vacuuming checks confirmed that vacuum performance itself was sound. The bubbles were regular and arranged in lines.

We then noticed that the bubble lines sat directly above the heating pipes. After reducing temperature and retesting, bubbles no longer appeared—but some areas of the laminate were less transparent. That pointed to uneven heat: glass above the pipes ran hotter than adjacent zones.

Because the heating pipes sit under the silicone bag, the portion of laminated glass directly above the pipes reaches a higher temperature. Oven temperature is not uniform. When temperature is too high, the copolymer and compounds break down and produce gas, which forms bubbles inside the laminated glass.

**Recommendation:** work with the EVA glass lamination oven manufacturer to modify the oven for more even heat distribution. Lowering set-point alone can stop gas bubbles but may leave cooler zones under-cured and less transparent—uniformity is the durable fix.
