# CNCGLASS

## TECHNICAL NOTE

### How to Recycle Unsuccessful Laminated Glass with EVA Film

By Peter Lin

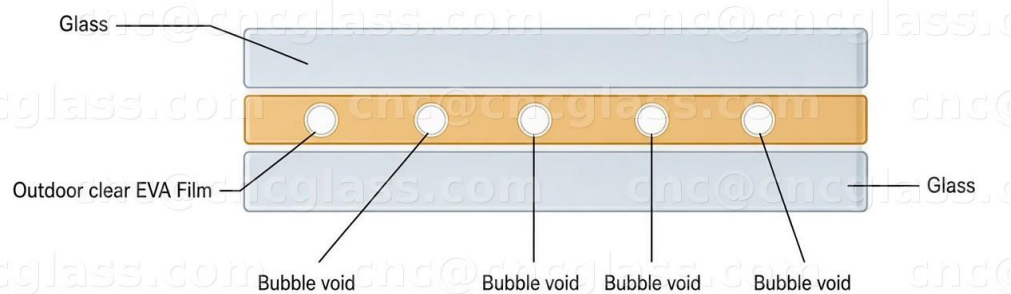
Industry practice for laminated-glass bubble rework is cautious: sealed internal bubbles away from the edge, milky haze, or adhesion failure are often not reliably repairable by re-autoclaving. Edge-connected residual air may sometimes respond to controlled pressure/heat completion; locked-in voids after full cross-link may not. Treat autoclave re-press as a conditional remediation attempt, then inspect optically and for adhesion before any delivery decision.

Problem schematic (cross-section): Glass → Outdoor clear EVA Film → Glass with annotated bubble voids trapped in the interlayer.

- Confirm glass type (annealed / tempered / heat-strengthened) and that the panel can safely enter the autoclave cycle available in your plant.
- Record bubble map (edge-connected vs sealed internal) before and after the attempt.
- After re-press: inspect for remaining voids, haze, edge delamination, and optical clarity. Pass only if optics and adhesion meet your workshop QC; otherwise scrap or move to degum reclaim.

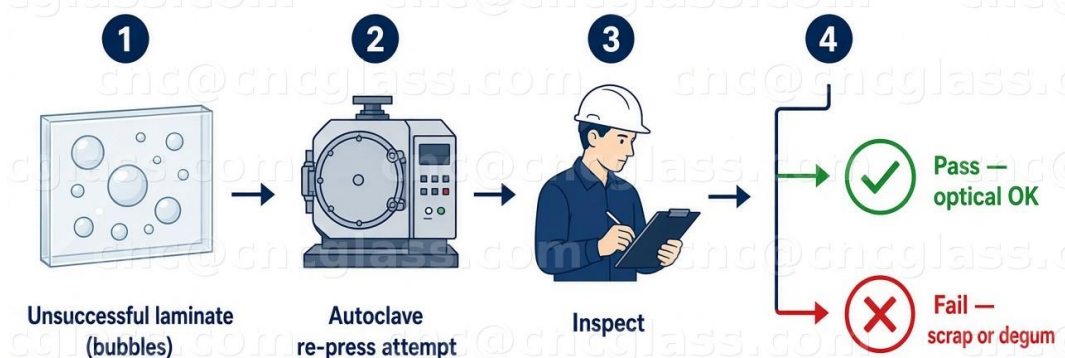
Remediation path: unsuccessful laminate with bubbles → autoclave re-press attempt → inspect → Pass (optical OK) or Fail (scrap or degum).

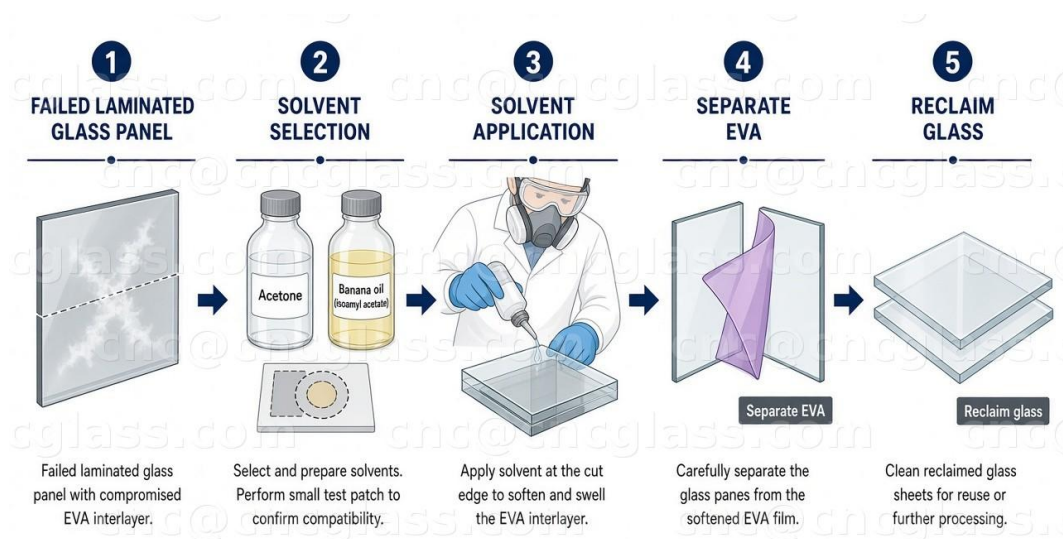
Chemical degum path: failed laminate → acetone + banana oil (isoamyl acetate) with small pilot test and PPE → separate EVA → reclaim glass.

- Take a small test first on a scrap edge or coupon of the same unsuccessful laminate before treating a full panel.
- Cut or open edges so solvent can reach the EVA interlayer; apply acetone and banana oil (isoamyl acetate) as needed to soften / weaken adhesion.
- When adhesion weakens, separate the panes and remove residual film; clean glass surfaces and inspect for coating etch, scratches, or edge damage before reuse.
- Reclaim glass only when fully cleaned and inspected. Do not claim 100% reclaim yield — some panes may still be scrap after degum.
