# CNCGLASS

## CASE STUDY / TECHNICAL NOTE

### How to Solve Glass Haze After Lamination

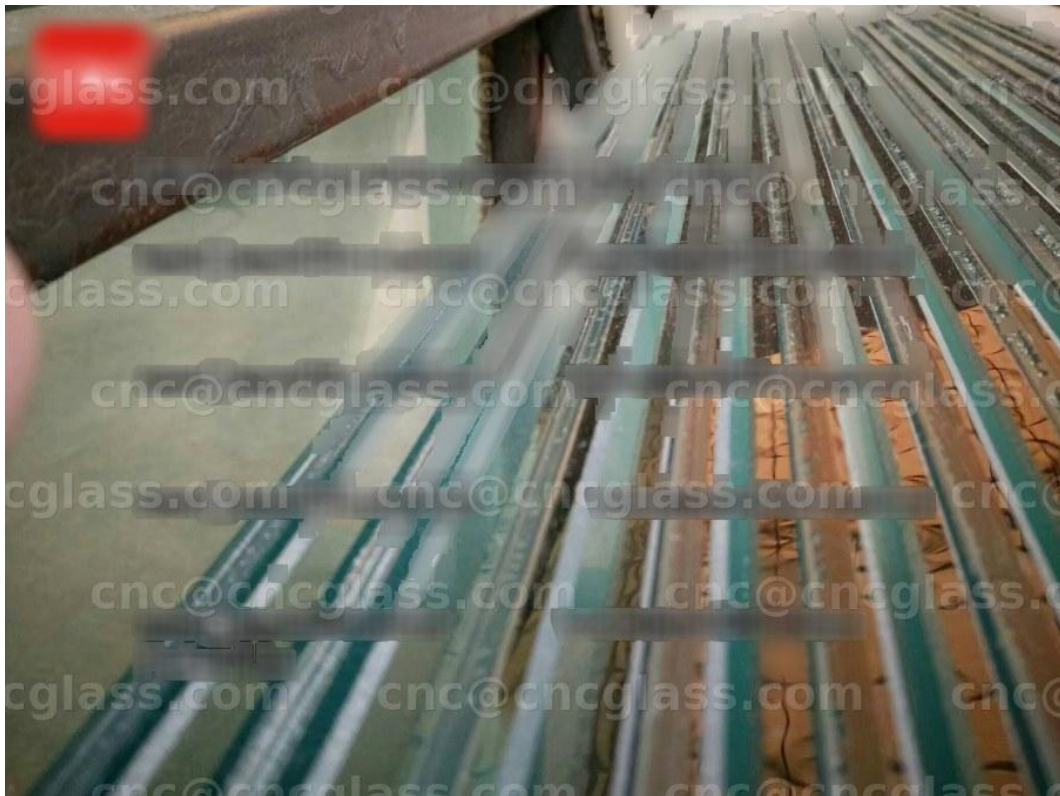
Figure 1. EVA laminated glass panels (edge view) — typical finished safety glazing stack; archive product photo (overlay contact text softened; watermarked).

**Glass makeup:** 2 × 8 mm toughened clear glass + 2 × 0.76 mm EVAFORCE EXTREME.
