**Company: CNC Ucolin Interlayer Technology Co., Ltd.**

## TECHNICAL NOTE

### Spontaneous Breakage (Self-Explosion) Solutions When Processing EVA Film Laminated Glass

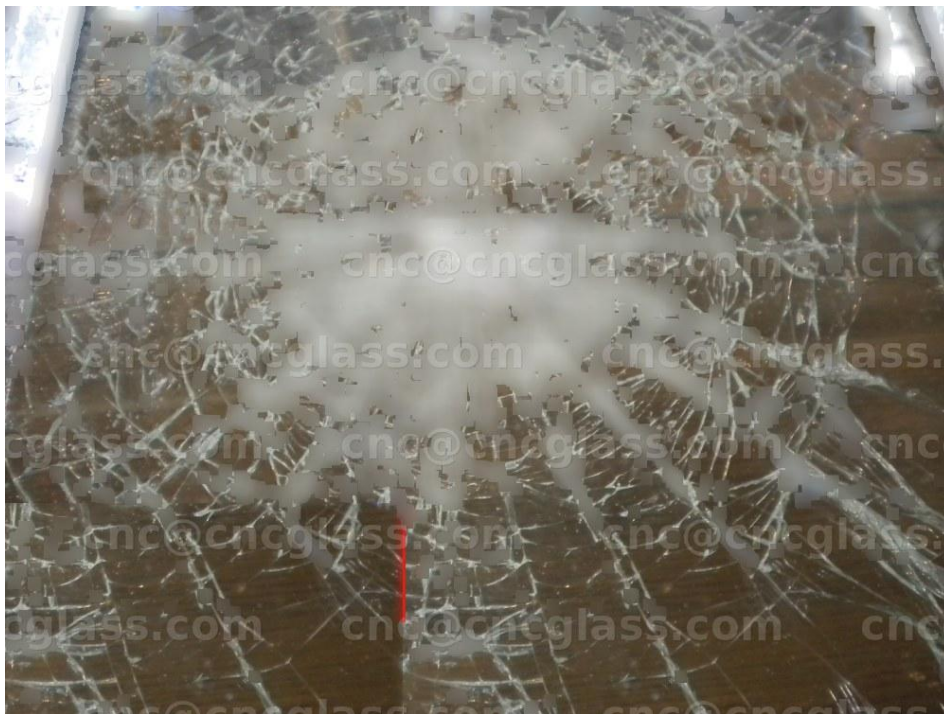
Figure 1. Example of shattered safety laminated glass (fragments retained by the interlayer). Rapid cooling, thermal shock, residual film stress, poor glass quality, or a hard point under vacuum can initiate such breakage during or after EVA processing.

If the laminated glass cools too quickly, thermal stress can initiate breakage. Do not open the oven door to force cooling after the temperature of the laminated glass is lower than 75 °C. Allow a controlled cool-down with the door closed once the laminate is below 75 °C.

Avoid letting hot laminated glass touch cold water. Sudden hot-to-cold contact creates thermal shock (surface contraction while the core remains hot) and can crack or shatter the laminate.

Place wood blocks between laminated glass sheets so that cooling is evenly distributed across the stack. Gaps for air circulation reduce local hot spots and uneven contraction that can lead to breakage.

Glass of poor quality is more prone to spontaneous breakage. Use better glass with sound edges and fewer defects. Edge chips, inclusions, and residual tempering or handling damage raise the risk of delayed or process-related failure.

Prefer EVA film whose manufacturer has properly relieved internal stress, and follow the grade's recommended lamination process.

If the silicone vacuum bag is not clean—for example if a hard block or debris remains inside—the pre-laminated glass may sit on that raised point. When vacuuming starts, concentrated pressure at that point can break the laminated glass. Keep silicone bags clean and free of foreign objects before every cycle.
